# EVALUATION, INVESTIGATION TECHNIQUES AND POSSIBILITY OF MALFUNCTION OF ELECTRIC SYSTEM OF TU-154M

Jacek F. Gieras

The paper discusses the electric power system of the Tu-154M. After brief introduction to aircraft power systems, the results of reverse design and analysis of  $\Gamma T40\Pi\check{C}6$  wound-field synchronous generator including short circuit have been presented. An example of failure of  $\Gamma T40\Pi\check{C}6$  is the fire of the Tu-154B-2 on January 1, 2011 before taking off at Surgut airport (flight 7K348). Guidelines for proper investigation of aircraft electric equipment and wiring after crash have been given. There is no evidence of examination of most electrical equipment of the Tu-154M nr 101 after crash on April 10, 2010. It is now extremely difficult to determine, if the electric system of the Tu-154M Nr 101 was operating correctly in the last seconds of flight, or not.

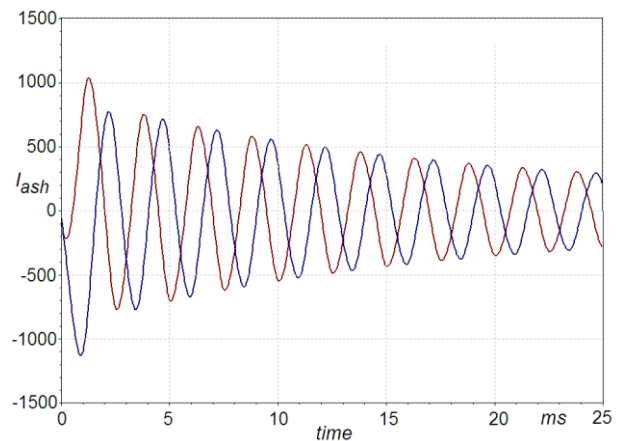
Fig. 8. Armature current  $I_{ash}$  at two lines-to-neutral short circuit of ГТ40ПЧ6 synchronous generator. The peak short-circuit current is  $I_{ashp} = -1130$  A corresponds to  $t = 0.6$  ms.

Short-circuit currents of the ГТ40ПЧ6 synchronous generator can exceed more than 11 times the nominal (rated) current  $I_a = 111$  A. The most dangerous are line-to-neutral and two lines-to-neutral short circuits. Fig 8 shows the armature current  $I_{ash} = f(t)$  waveforms for two lines-to-neutral short circuits, as obtained from the 2D FEM.

The abnormal paralleling of two unsynchronized ГТ40ПЧ6-2С generators causes serious consequences. The generators were connected on the network after the engine start and exit to the idle mode. Under such conditions the currents can reach more than 10 times the nominal current of the generator (Fig 8).

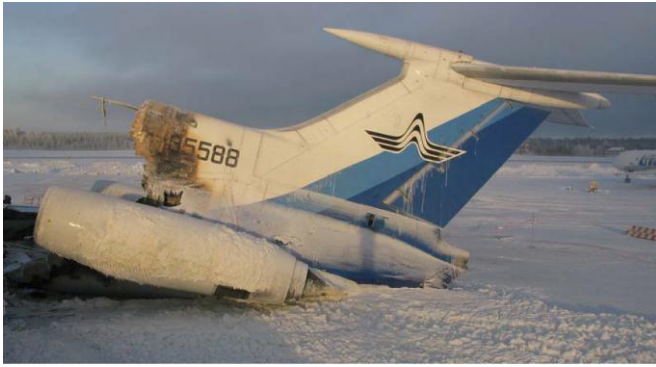
Russia's Interstate Aviation Committee (IAC) released their final report (in Russian) concluding the probable cause of the accident was the outbreak of fire in the right generator panel located between frames 62 and 64 in the cabin [2].

Fig. 9. Tail part of Tu-154B-2 RA-85588 after fire at Surgut airport on January 1, 2011 [2].

The cause of the fire was an electrical arcing produced by electrical currents exceeding 10 to 12 times the nominal current when two generators not synchronized with each other were brought online but got connected together instead of being connected to parallel busses. The unsynchronized operation of the generators can be attributed to:

- Poor technical conditions of contacts TKC233Д0Д responsible for connecting the generators with the electrical busses, that were damaged by prolonged operation without maintenance. A contact normally open was welded and fractured insulation material moved between contacts that are normally closed. These abnormal contact positions led to the connection between No 2 and No 3 generators (Fig. 10).
- Differences in the schematic diagrams of generator No 2 and generators No 1 and 3. When the switch is moved from "check" to "enable" with no delay in the "neutral" position, the generator 2 is brought online without time delay. This leads to increased wear of normally closed contacts in the TKC233Д0Д unit. The specific design of the electrical systems ensures power supply to each bus from either the APU or engine integrated drive generator.

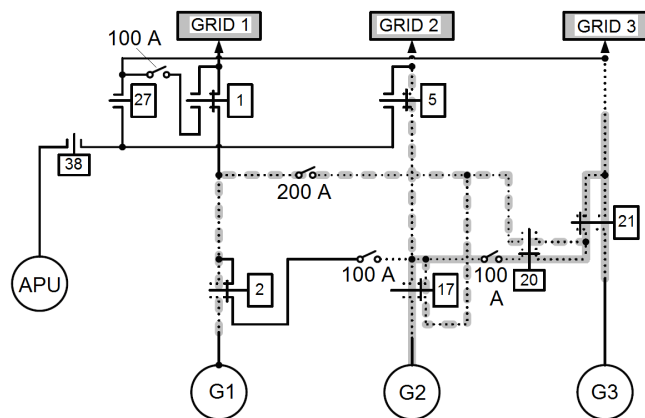
Fig. 10. Closed electric circuit on assumption of abnormal scenario corresponding to 21st contactor TKC233Д0Д "switching generator No 3 on grid" [2].

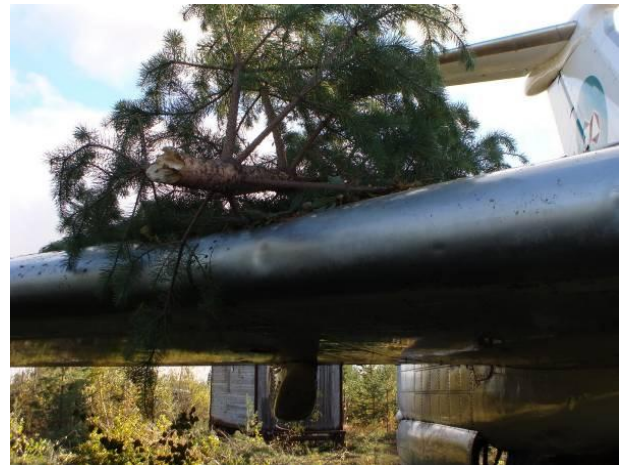
Fig. 11. Emergency landing of Tu-154M RA-85684 at abandoned air strip near town of Izhma on September 7, 2010. The impact was damped by the young trees which have grown since the airport was closed. The photograph shows the right wing that cut a pine tree. <http://englishrussia.com/2011/11/04/the-lucky-tu-154/#more-74596>

After emergency decent below cloud level the crew were able to spot an abandoned air strip near town of Izhma (Fig. 11). The abandoned air strip is 1325 m long, whereas Tu-154 requires a minimum of 2200 m. The aircraft landed at a speed of 350 to 380 km/h, faster than normal, due to the lack of flaps. Although the flaps are powered by hydraulics, the switches operating them are electrical. All nine crew and 72 passengers evacuated using the aircraft's evacuation slides. No injuries were reported.

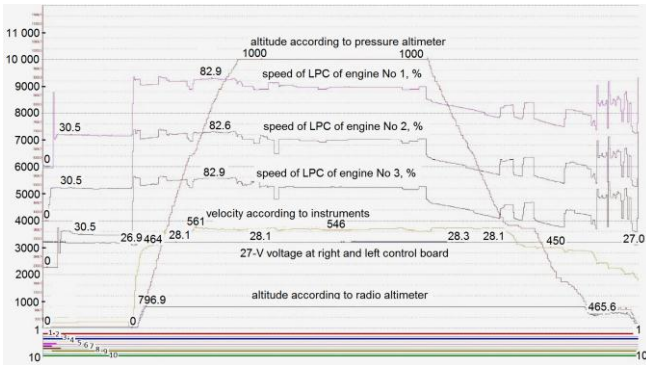
**Fig. 12.** Parameters of flight of Tu-154M Nr 101 for electrical equipment and installation on April 10, 2010, 7:14– 8:41 am. LPC = low pressure compressor. Description in Table 4 [4].

Credibility of flight parameters for electrical equipment and installation (Fig. 12) is questionable. There is not enough information how the recorded parameters have been extracted and analyzed [4]. It is now very difficult to find out if the electric power system was operating correctly in the last seconds of crash or not. According to [3,4], the flight management system (FMS) lost electric power (memory freezing) at 10:41:05, i.e., at the time of collision with ground. Table 3 show standard procedure for examination of electrical equipment and installation after crash [1,11]. The electrical equipment and wiring at the crash site was only inspected visually [3,4]. There is still possible to examine synchronous generators and induction motors for fuel pumps and for other on-board equipment, e.g., air conditioning system. However, the results of examination may not be credible since the wreckage was carelessly loaded on the trailers, and then transported, unloaded and stored in open space without any caution.

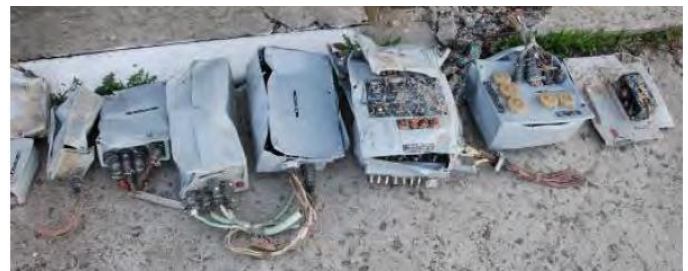
**Fig. 13.** Junction and control boxes of electrical installation. Photo taken at the site of wreckage storage [4].

There is no evidence that other than visual inspection of electrical equipment and wiring (Table 3) has been done on the crash site [3,4]. The following statement is given on p. 20/28 of Annexure 4 [10]: *Bundles of electrical wires torn apart. Control boxes deformed. Enclosures of on-board batteries deformed. Some cells leaking.* The report shows photographs of wire bundles, control boxes (Fig. 13), synchronous generator ГТ40ПЧ6 on the turbopan engine Nr 1 (Fig. 14), batteries and other electrical equipment.

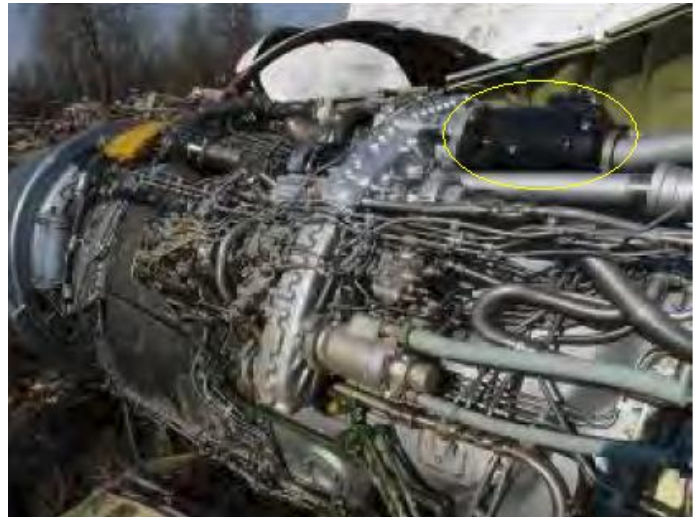
**Fig. 14.** Generator ГТ40ПЧ6 on Nr 1 (left) Д-30KY turbopan engine. Photo taken between 11 and 13 April 2010 on the crash site [4].

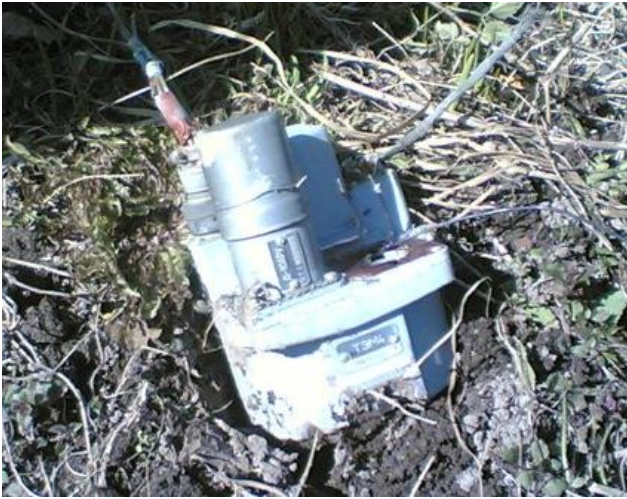
Fig. 15. Electromagnetic brake TЭM-4 for flap control found several meters behind the famous birch tree. Source: <http://www.waronline.org>

The object found at the crash site several meters behind the famous “armored” birch tree [3] and shown in Fig. 15 has been often incorrectly identified as a fuel pump. However, this is the electromagnetic brake TЭM4 used for control of flaps (Fig. 16).
