AN ENGINEERS VIEW ON HOW THE SMOLENSK CRASH COULD TAKE PLACE

Glenn Arthur Jørgensen

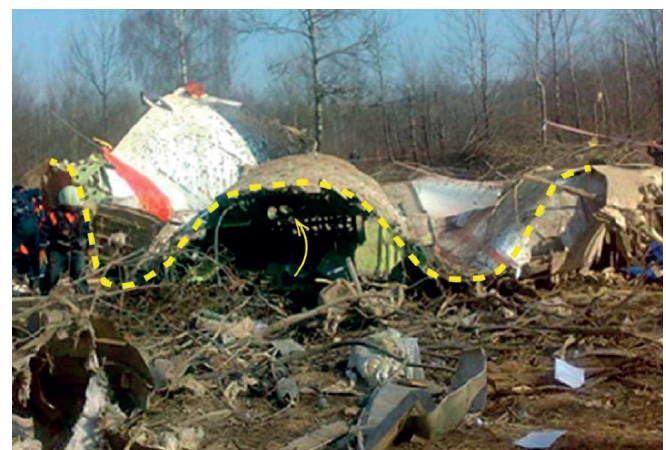
Fig. 5. Part of the inverted hull. It is clearly opened (yellow line and arrow) [5].

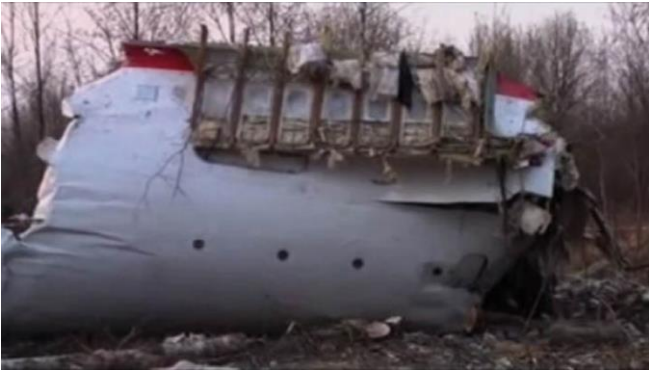
Fig. 6. The front bottom section below the president's salon. The entire top section is pulverized and the window section was thrown outwards most likely caused by the high internal pressure at the near ground explosion. Note the windows have not been in ground contact [7].

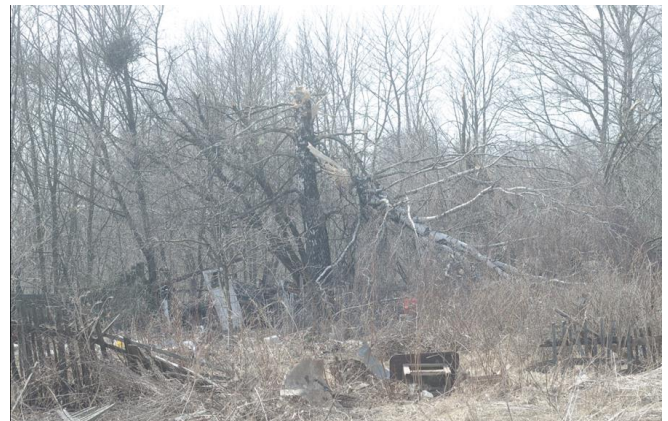
the official story. It seems on this background impossible, that the fence to the left and right of the laying portion would be standing, nor would the middle section just be tipped over. The author encourages the reader to watch the YouTube video [13] and judge for herself.

Fig. 10. The Russians claim this is what happened to the fence, which in that case has proven to be unbelievable strong.

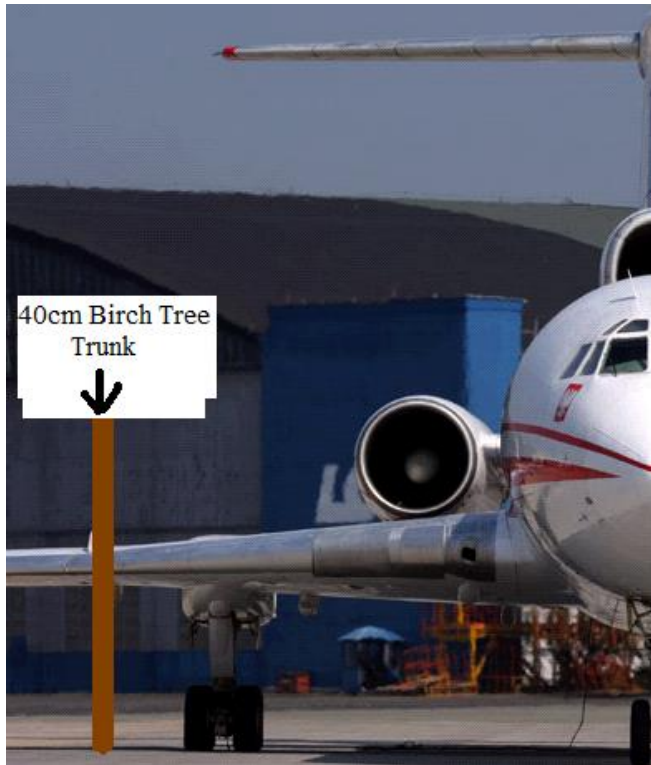
Fig. 13. The birch tree claimed to have cut the wing was 30cm - 40cm in diameter. This is illustrated together with the wing of the TU-154M at the point the wing needs to be cut to force a roll of the plane as logged by the black boxes.

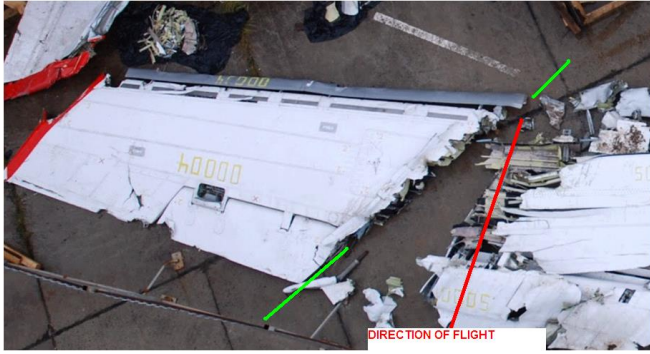
Fig. 21. The wing tip from P101 is cut along the line going from the natural division between the slats (point C) to the edge of the aileron. The crash engineer would warn that no good explanation can be given to the public for this issue .

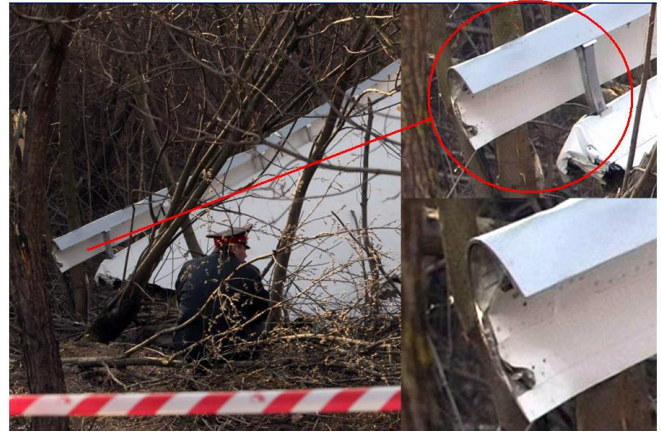
Fig. 22. The slat edge is clearly out of line with the line of cut. This is an unavoidable problem. The crash engineer would warn that no good explanation can be given to the public for this issue .

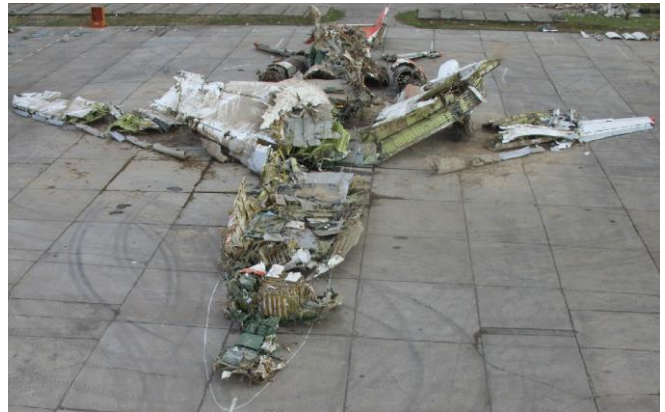
Fig. 24. The left and right wings show great similarity. Both are divided into: wing tip, center section in small pieces and the wing root. According to the official explanation the right wing was in free air all the time, and the left wing supposedly hit first a birch tree and later ploughed into the ground. The expected wing destruction should therefore be very different for the two sides left and right.

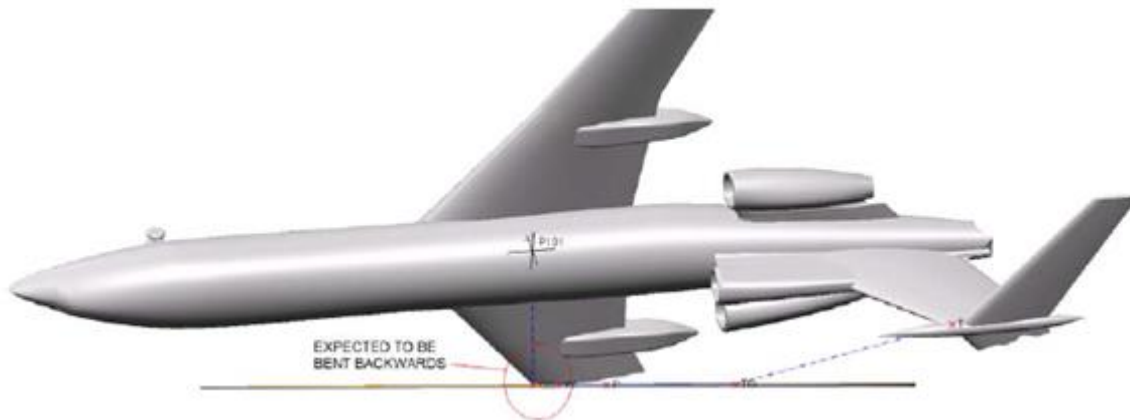
Fig. 27. The corner of the shortened left wing is expected to be bent backwards when making ground contact.

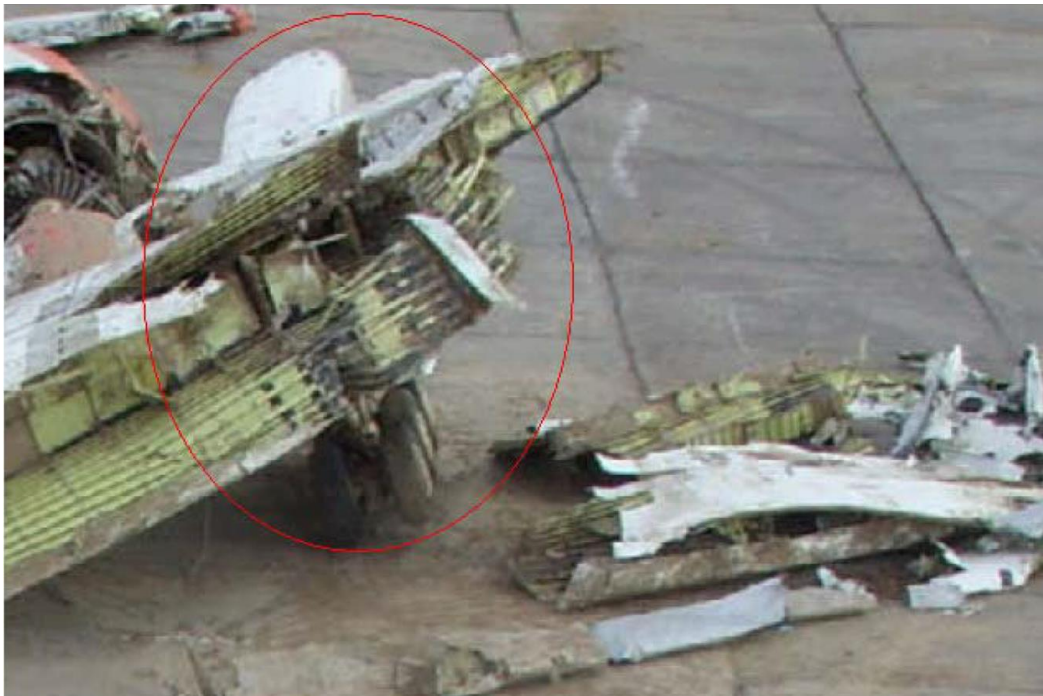
In the left inner flap is found to be in a position of 28° whereas the right flap is in a position of 36° [21]. Assuming it very unlikely that such difference exists during normal flight, this points towards a manipulation of the flaps after the flight ended. The self-locking spindle system excludes this happening during the crash itself. This could point towards the change occurring after the crash. The damage of the left spindle that was present after the crash makes it unlikely that this side could be manipulated. The conclusion of this that the flaps most likely were in a position of 28° prior to the wing loss, and therefore configured by the pilots for the go-around (flaps setting 28° for go-around) rather than for a landing (flaps setting is 36° for landing). Fig. 27 show the plane as it makes the first ground contact. The edge of the shortened left wing is expected to be bent backwards, and this can be observed in Fig. 28. Also the signs of ground contact and the parts with no sign of ground

contact shown in Fig. 28 agree with the hypothesis of a wing loss of about 10 m wing.

Fig. 28. The edge of the left wing root is bent backwards and shows clear sign of ground contact, so does the inner part of the slat, where the neighbour part of the slat shows no sign of ground contact. The bottom part of the middle section of the wing shows sign of ground contact, where the top part broken in fine sharp edged debris characteristic by explosion like described in Fig. 27. These observations agree with the hypothesis of wing loss by two explosions put forward in [2] and [7].
