ANALYSIS OF COMPONENTS OF ELECTRIC SYSTEM OF THE TU-154M PLF 101 AFTER CRASH

Jacek F. Gieras¹⁾, Marek Dąbrowski²⁾

Abstract

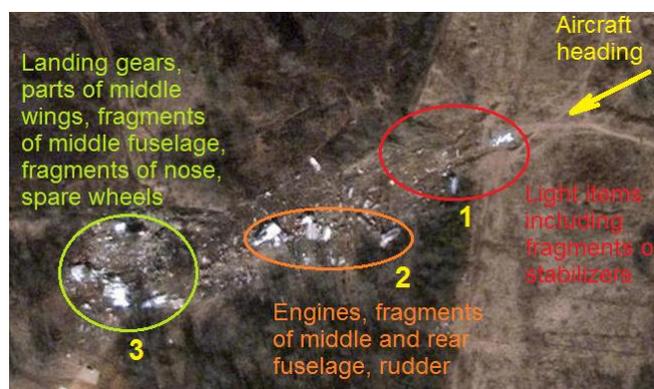
- distribution of debris (Fig. 1);
- large number (tens of thousand) of small parts on the crash site;
- fragments of the aircraft skin on trees;
- lack of crater;
- lack of fuel (at least no records) and fuel fire on the ground.

Fig. 1. The Tu-154M PLF 101 wreckage trail plot grouped by location of parts of the aircraft: (1) light items including fragments of stabilizers; (2) engines, fragments of middle and rear fuselage, rudder; (3) landing gears, parts of middle wings, fragments of middle fuselage, fragments of nose, spare wheels.

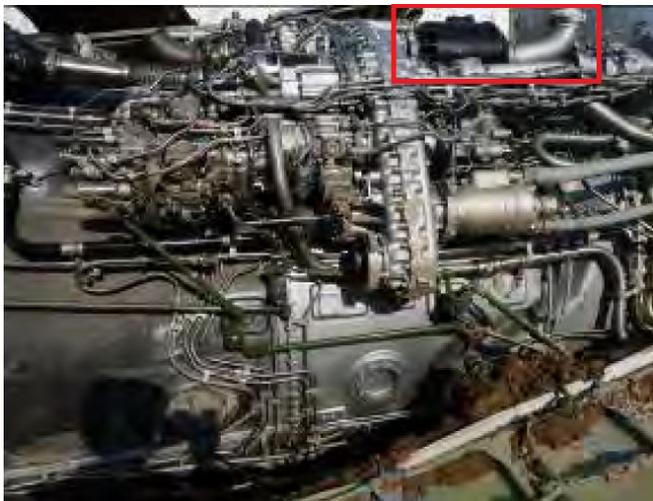
Fig. 4. Generator ГТ40ПЧ6 on the engine No 1 (left). The engine cover (cowl) has been removed. Photo taken between 11 and 13 April 2010 on the crash site. Source: Annexure No 4.10.22 to KBWLLP Report [6].

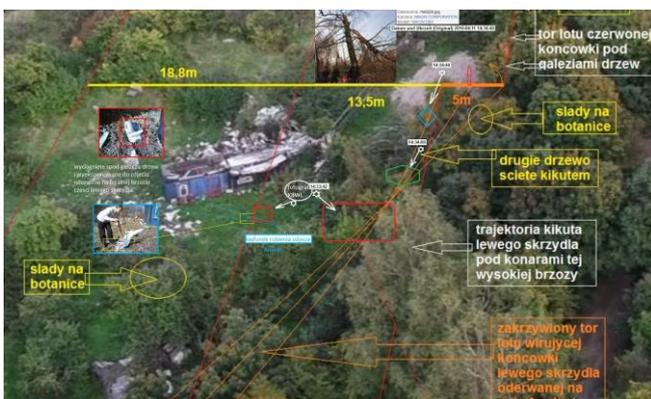
Fig. 8. Location of screw actuator of flaps and electromagnetic brake ТЭМ-4 on N. Bodin's lot before Gubenko Street. Source: elaboration by blogger *Wielki55*.

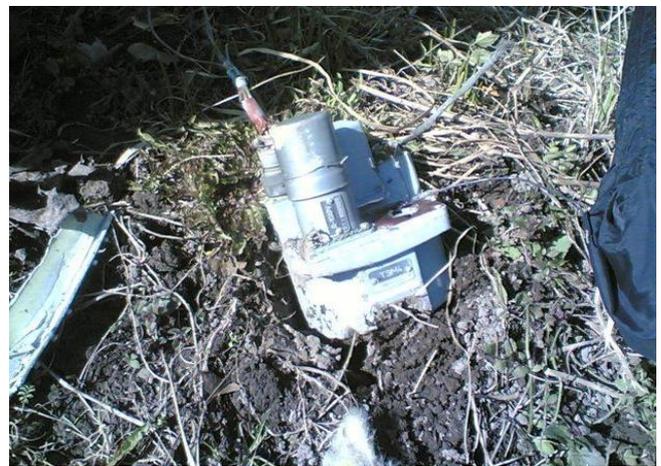
Both photographs in Fig. 9 and Fig. 10 have been downloaded on April 10, 2010 at 18:44 by a Russian blogger MAKS at <http://www.forum.smolensk.ws>. The photograph of the same parts shown in Fig. 11 has been taken later. The authors' request for the date and time of this photograph being e-mailed to the Team for Explanation of Causes of Smolensk Crash [7], personally to M. Lasek, the chairman, has remained unanswered.

Fig. 9. Electromagnetic brake TEM-4. Photograph taken probably on April 10 2010 before 18:44. Source: <http://www.forum.smolensk.ws/viewtopic.php?p=6889622#p6889622> Author: MAKS.

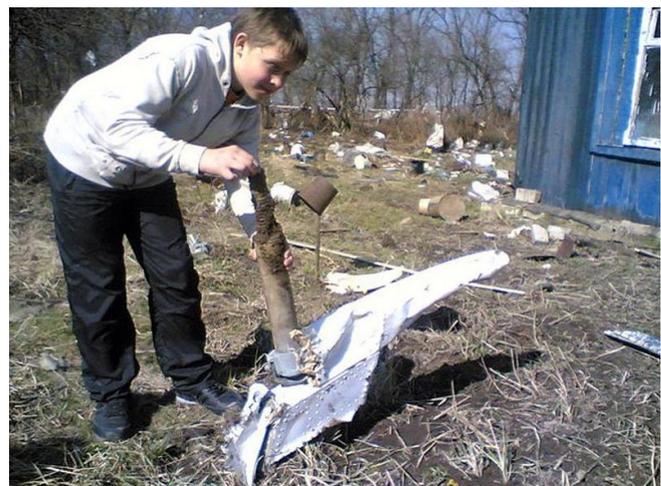
The photo of the screw actuator of flaps (Fig. 10) shows that this part dropped from the aircraft before the birch tree at N. Bodin's lot. The Interstate Aviation Committee (MAK) report [8] indicates the location of the actuator behind the birch tree (Fig. 7). Without doubt, the illustrative material in figures Fig. 8 to Fig. 11 is a proof that the screw actuator of flap control and electromagnetic brake ТЭМ-4 have been intentionally moved at the crash site to make the official version of the crash [8, 9, 6] more authentic. In the official version of the crash [8, 9, 6], the "armored" birch tree is the main cause of the crash.

Fig. 10. Screw actuator of flaps found near N. Bodin's shed. Source: S. Amielin [10].

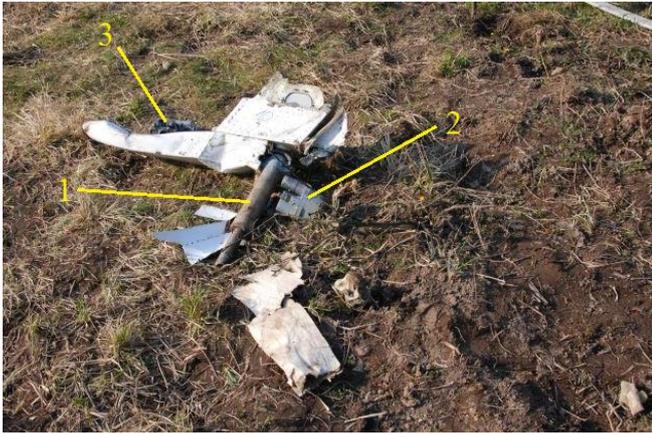
Fig. 11. Screw actuator for left wing flaps (1), electromagnetic brake ТЭМ-4 (2) and reducer (3). Photo taken by IAC (MAK) [8] Source: www.faktysmolensk.gov.pl

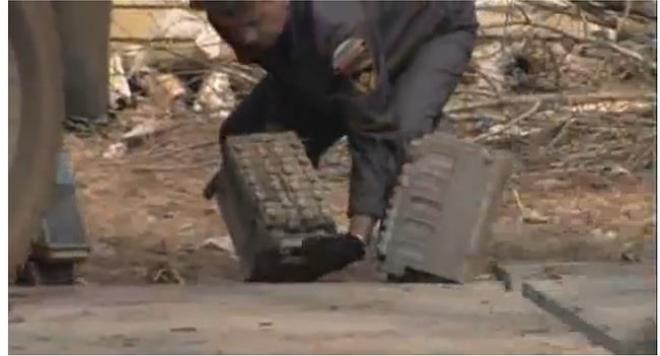
The Tu-154M aircraft is equipped with four 20HKБН-25-Y3 batteries and two spare batteries. Three out of six of the 20HKБН-25-Y3 batteries of the Tu-154M PFL 101 have been found undamaged at the crash site (Fig. 14).

Fig. 14. Undamaged batteries at the crash site. Source: SuperVizjer_Smolensk_4.wmv (<http://www.youtube.com/watch?v=dB08tmb12TQ>).

7. **Ni-CD batteries 20HKBH-25-Y3.** The available photo of 6 batteries shows that the three of them are visually in good condition, while the remaining 3 batteries are with damaged covers (broken and bent).

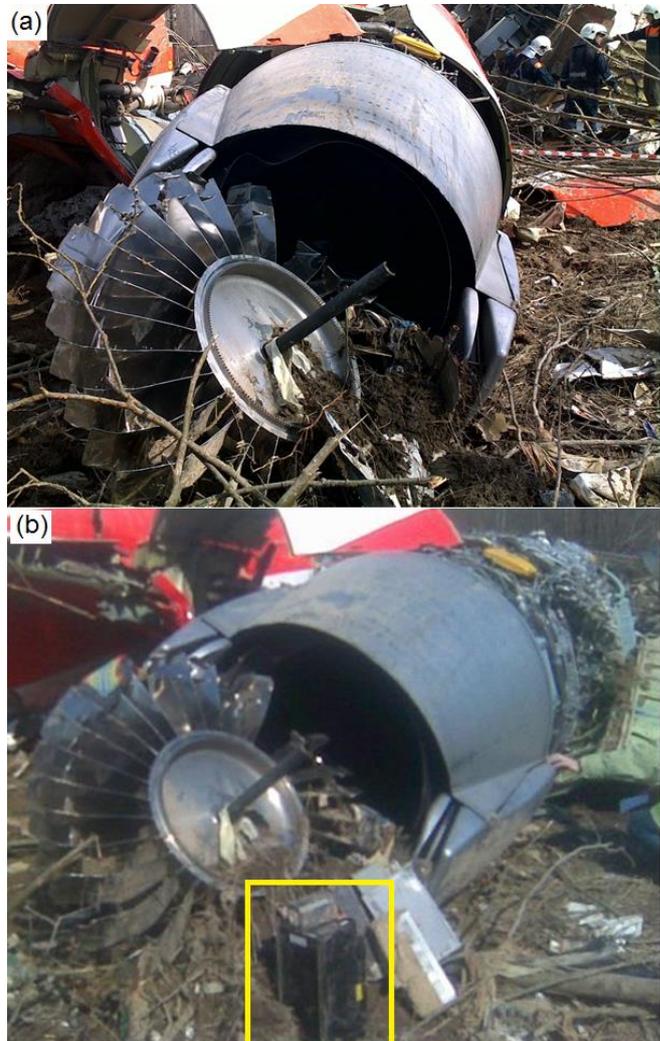
Fig. 15. Low pressure compressor (LPC) of the left engine No 1 at the crash site. (a) the blades were spinning before touching the ground because their tip portion is covered with soil (b) the object in rectangular frame beside the LPC is probably the battery 20HKБН-25-Y3. Source: Fig. 15a www.faktysmolensk.gov.pl , Fig. 15b unknown source.

It is impossible to locate on the basis of available illustrative material where the batteries have been dropped after the crash. Fig. 15 shows that the batteries have been moved at the crash site from place to place.

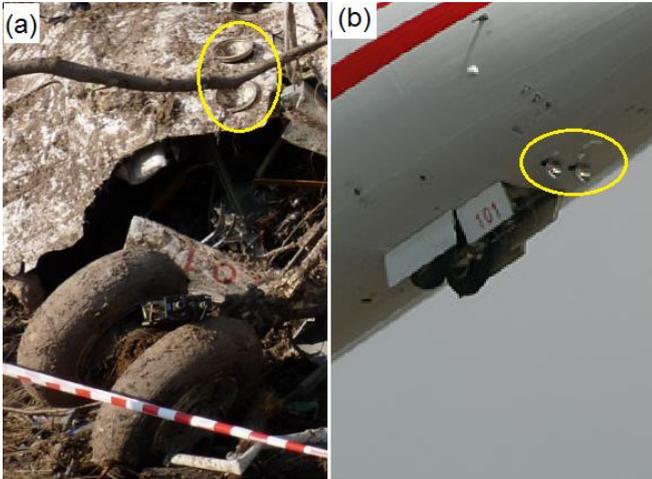
Fig. 16. Landing/taxi lights PRF-4 mounted on the fuselage of the Tu-154M PLF 101: (a) found on the crash site with broken glasses [8], (b) ejected lights at landing approach. Source: Fig. 16a Raport IAC (MAK) [8], Fig. 16b M. Franczyk, www.galeria.aviateam.pl.

Each time, when the TU-154M approaches landing, the PRF-4 lights are always ejected, both at daytime and nighttime (Fig. 16b). It is enigmatic that after the crash the landing lights looked like in stowed position (Fig. 16a and Fig. 17).

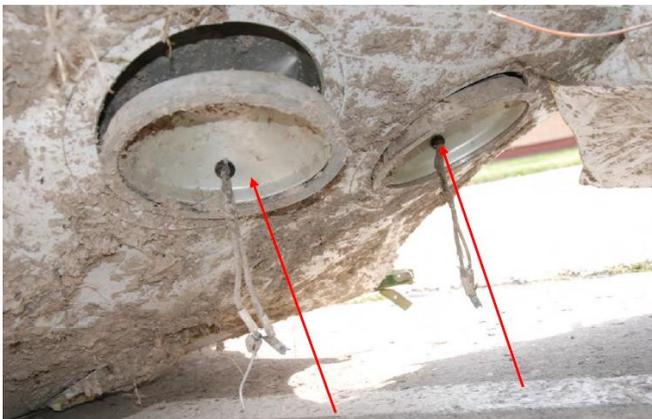
Fig. 17. Condition of landing/taxi lights PRF-4 mounted on the fuselage of the Tu-154M PLF101 after the crash. Photograph taken at the place of storage of the wreckage. Source: Annexure No 4 KBWL [6].

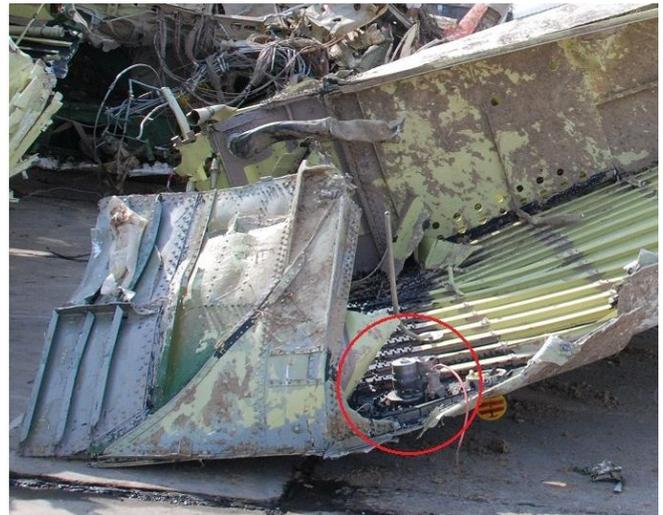
Fig. 18. Fuel booster pump ЭЦН-325 of the wing fuel tank in the left centerwing. Photograph taken at the place of storage of the wreckage. Source: www.fakty.molensk.gov.pl [7].

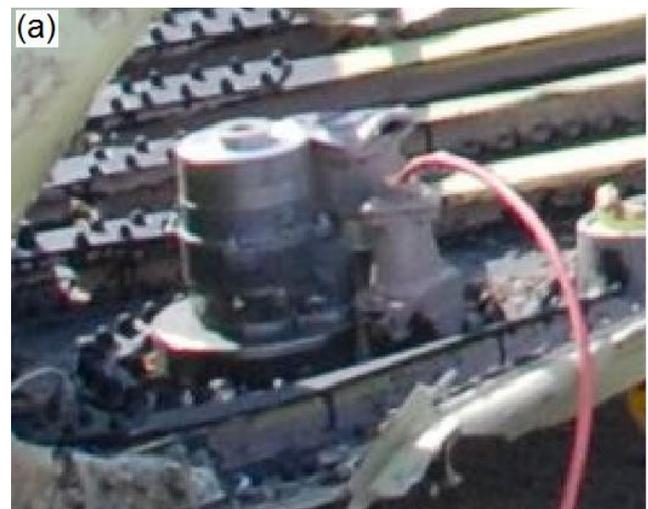
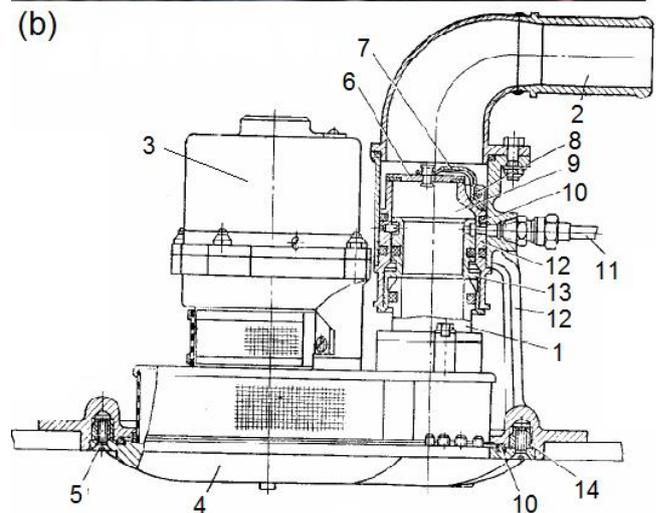
Fig. 19. Identification of the fuel booster pump ЭЦН-325: (a) magnified circled area of Fig. 18; (b) outline of the fuel booster pump ЭЦН-325 [3]: 1 - tubes, 2 - induction motor driven pump, 3 - cover, 4 - screw, 5 - disk cover, 6 - lever, 7 - spring, 8 - non-return valve, 9 - rubber ring, 10 - pipeline, 11 - body, 12 - base, 13 - fittings.

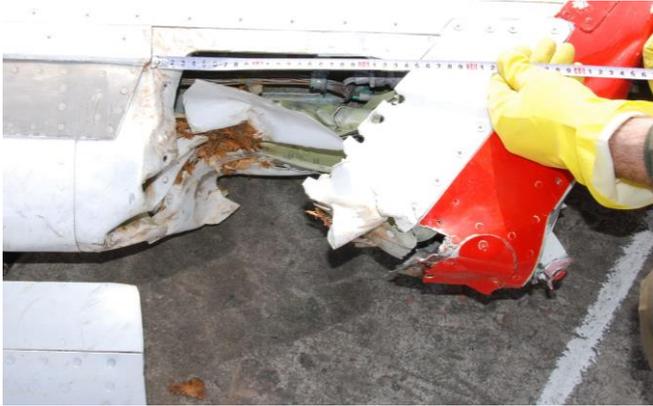
Fig. 20. A bundle of electric wires located before front spar of the detached portion of left wing. The front skin has been probably damaged when the severed part of wing hit the bushes at the crash site, while dropping. Note that slat covering the front skin has not been damaged Source: www.faktysmolensk.gov.pl [14 7].

A bundle of electric wires located before front spar of the detached portion of left wing is shown in Fig. 20. These wire can either be for energy delivery to the heating elements (de-icing of slats), to the fuel pumps, or electric

lighting. The front skin of the wing has been ripped of, while the slat covering the front skin has not been damaged.

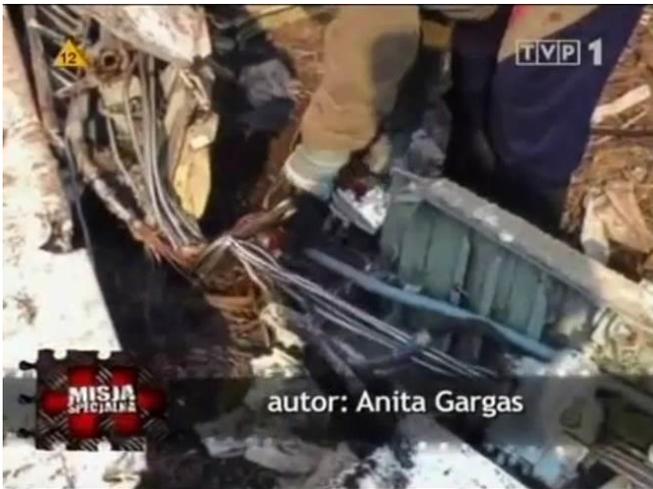
Fig. 21. Destruction of electric wiring and pneumatic hoses and tubing fixed the wing spar during rescue action at the crash site. Photo: A. Gargas, „Special Mission”, Polish TVP1 program.

Fig. 21 shows how the pneumatic hoses and tubing and electric wires have been destroyed by Russians at the crash site.

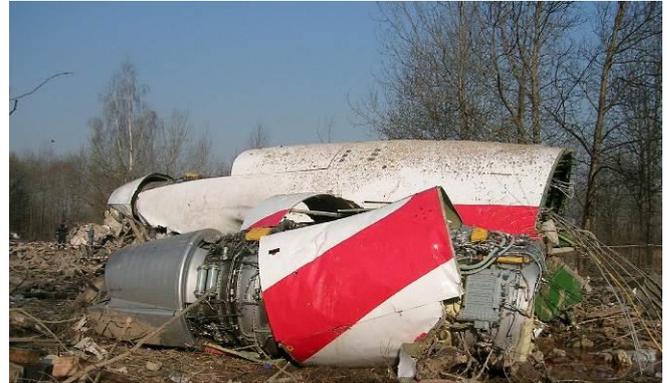
Fig. 22 and Fig. 23 show bundles of electric wires pulled out of the fuselage as a result of axial forces acting inside the fuselage. The origin of these forces can only be explained by internal explosion in the fuselage.

Fig. 22. Distinctive bundles of electric wires pulled out from the rear portion of the fuselage torn around the frame No. 65 at the crash site [5 8].

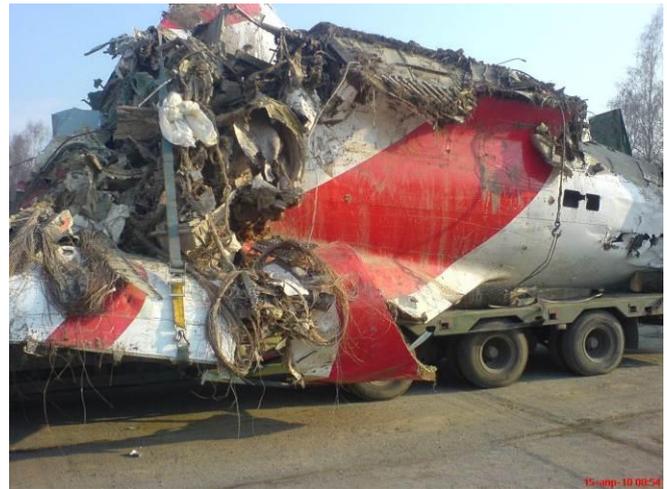
Fig. 23. Transportation of the rear portion of the fuselage shown in Fig. 22 from the crash site to the storage place. Pulled out electric wires are clearly visible.

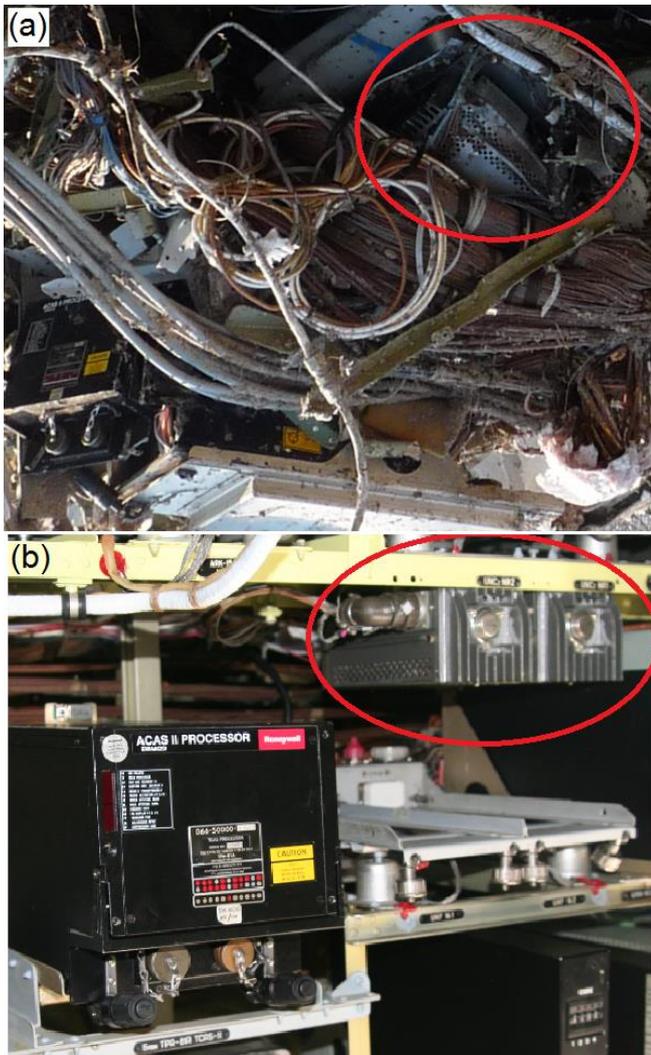
Fig. 24a shows low-frequency amplifiers YHЧ in the technical compartment No 1 (avionics compartment) after the crash, while Fig. 24b shows undamaged amplifiers of the Tu-154M PLF2. The compartment No 1 is located under the cockpit. The photograph in Fig. 24a, which shows a heap of debris is turned upside down with respect to the original photograph [7]. In the bottom left corner of Fig. 24 there is the airborne collision avoidance system ACAS, also called the traffic-alert and collision avoidance system (TCAS)¹ [7].

Fig. 24. Low frequency amplifiers YH4: (a) after the crash; (b) in the technical compartment No 2 of the Tu-154 PLF2. Source: www.fakty-smolensk.gov.pl [7].
