# EVALUATION, INVESTIGATION TECHNIQUES AND POSSIBILITY OF MALFUNCTION OF ELECTRIC SYSTEM OF TU-154M

Jacek F. Gieras

The paper discusses the electric power system of the Tu-154M. After brief introduction to aircraft power systems, the results of reverse design and analysis of  $\Gamma T40\Pi\check{C}6$  wound-field synchronous generator including short circuit have been presented. An example of failure of  $\Gamma T40\Pi\check{C}6$  is the fire of the Tu-154B-2 on January 1, 2011 before taking off at Surgut airport (flight 7K348). Guidelines for proper investigation of aircraft electric equipment and wiring after crash have been given. There is no evidence of examination of most electrical equipment of the Tu-154M nr 101 after crash on April 10, 2010. It is now extremely difficult to determine, if the electric system of the Tu-154M Nr 101 was operating correctly in the last seconds of flight, or not.

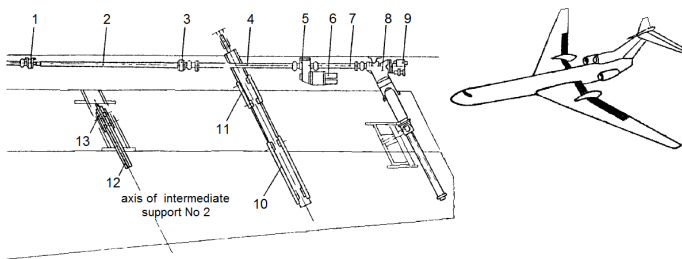
Fig. 16. Location of electromagnetic brake TЭM-4 for flap control. 1,3 - bracket, 2,4 - transmission shaft, 5 - reducer, 6 - electromagnetic brake TЭM-4, 7 - cardan joint, 8 - lift for the outer flap, 9 - mechanism of limit switches with sensor, 10 - rail of external deflector, 11 - carriage of external deflector, 12 - rail of deflector, 13 - intermediate carriage of deflector [9,10].

The object found at the crash site several meters behind the famous “armored” birch tree [3] and shown in Fig. 15 has been often incorrectly identified as a fuel pump. However, this is the electromagnetic brake TЭM4 used for control of flaps (Fig. 16).
