AN ENGINEERS VIEW ON HOW THE SMOLENSK CRASH COULD TAKE PLACE

Glenn Arthur Jørgensen

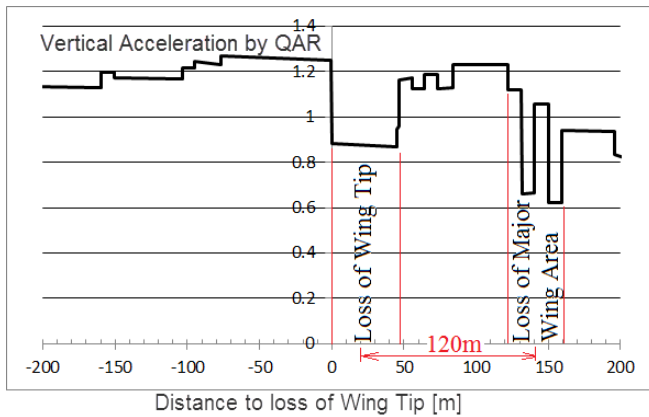
Such drop in the vertical acceleration signal explains there were two momentary losses in the wings lifting capacity. The fact that 1.) all ground traces suddenly stop at the same point about 0.3s after the wing made its first ground contact and 2.) the plane is found demolished into between 20.000 to 60.000 parts [5] (see Fig. 2) without the formation of a crater in the relative soft ground points towards an explosion of the fuselage, while the fuselage is above the ground [4]. For comparison Professor K. Nowaczyk [5] has listed, that the terrorist attack, known as the Lockerbie crash, took place at about 10km height with use of explosives on board the plane loaded with fuel. The separated parts of the plane fell to the ground with high

Fig. 1. The vertical acceleration data as logged by the Polish QAR black box. The distance flown by the plane between the loss of the wing tip and the loss of the major wing area is about 120m. Plane "flies" from left to right.

The black box data clearly show two distinct drops in the vertical acceleration sensor signal (see Fig. 1) with a distance of flight of about 120 m. A drop in the vertical acceleration is associated with a loss of lifting power of the wing. Following the second loss of wing area, the left rudder actuator shows an sudden and short erratic behavior for a short time not following the path of the right rudder actuator nor the commanded actuator signal. This can indicate, that parts from the left wing lost at this point colloid with the left tail section. When separating from the rest of the wing the wing fragments will tend to move upwards as a result of the aerodynamic force and explosive pressure forces acting on these. The tail of the TU-154M is a traditional "T" type, i.e. the horizontal section of the tail is located higher than the main wing section and thereby in the path of parts leaving the main wing. The left rudder actuator signal again makes erratic behaviour about 120m prior to the crash site. By satellite photos taken the 11th of April and 12th of April it is demonstrated, that the left horizontal tail wing hit the ground between this position and the crash site, but *was moved by the Russians on the night between the 11th and 12th April to the crash site position*, the latter position claimed to be the official position of this part.

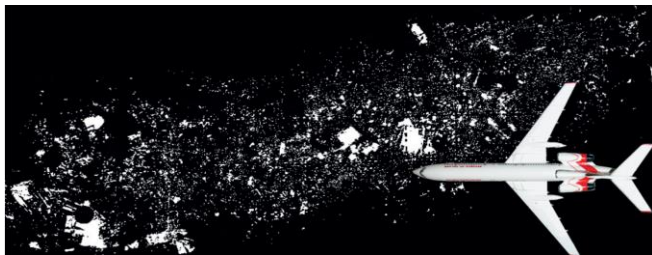
Fig. 2. A map of the debris found at the main crash site prepared for the Polish Archeologist report. The airplane in the bottom right corner shows the plane in the same scale [5].

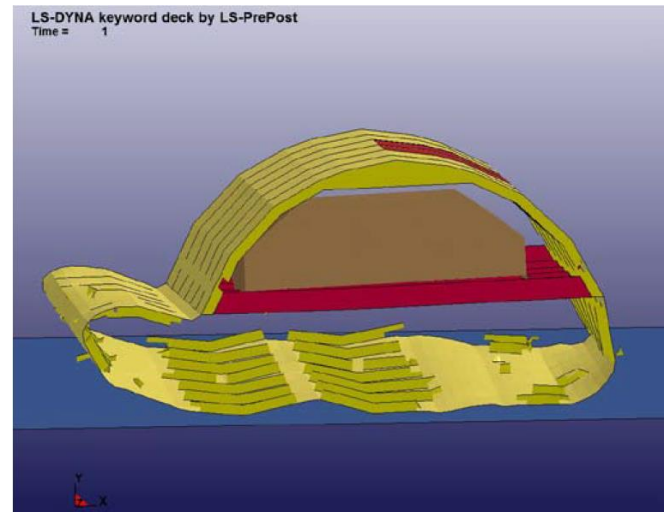
Fig. 3. Simulation of a vertical fall of the fuselage upside down without an explosion [1].

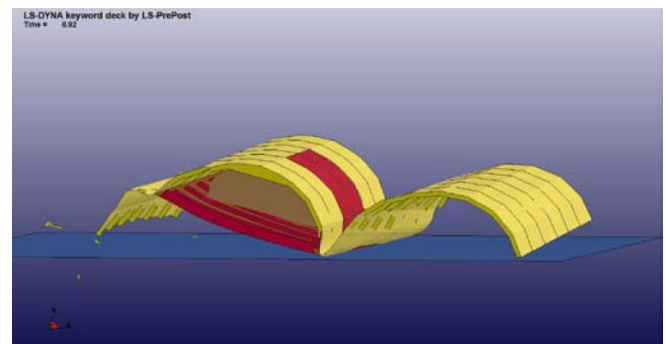
Fig. 4. Simulation of vertical fall of the fuselage upside down after the explosion [1].

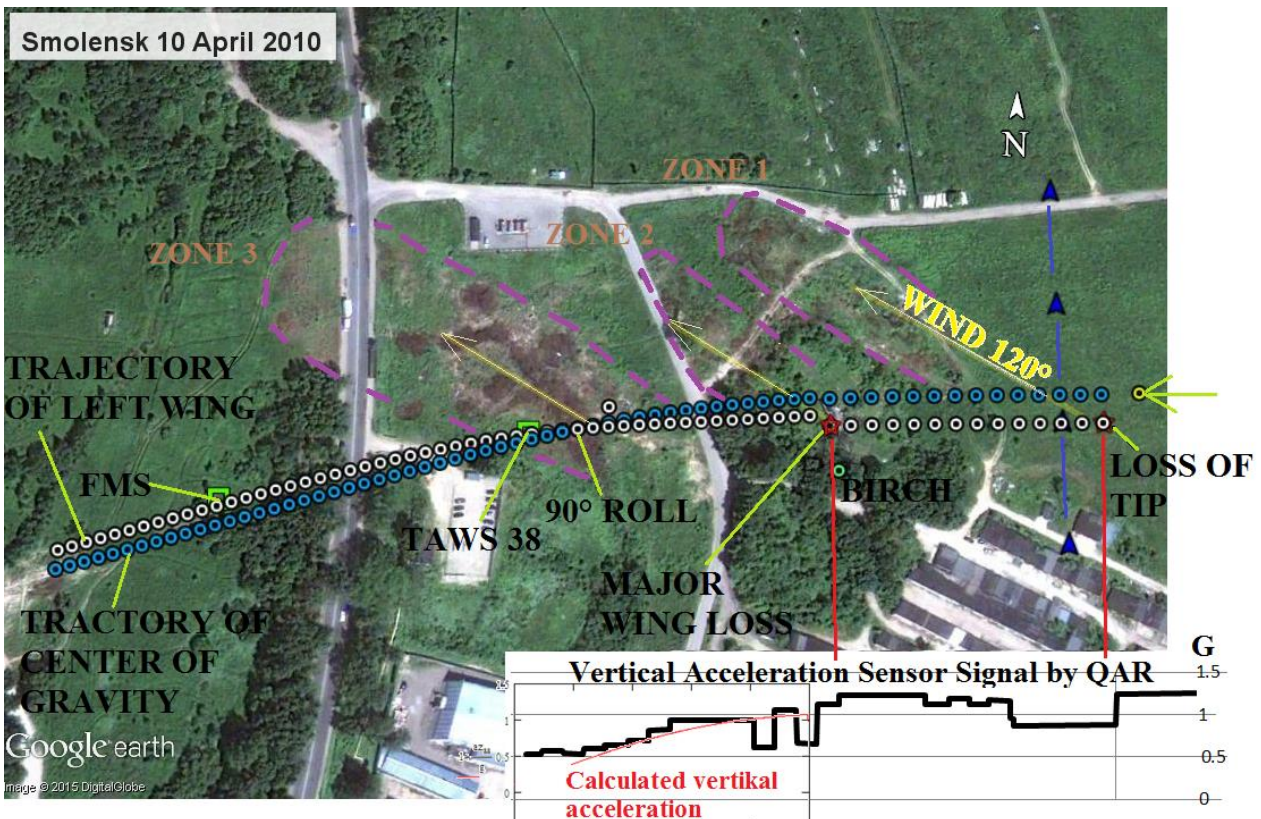
Fig. 7. The calculated trajectory for the center of gravity (blue) and the left wing tip (white). The satellite picture is from the 25th of June 2010 (two months after the crash). Notice the distinct and significant damage of vegetation in the three areas (zone 1, zone 2 and zone 3) circled by the dashed lines. Adding the recorded vertical acceleration signal by the Polish QAR (black line) and the wind direction of 120° show the clear correlation between the three distinct areas of vegetation damage to the approximate positions of 1. the loss of the wing tip, 2. loss of additional wing area and 3. the release of a large amount of fuel when the plane was rotated 90° most likely caused by a third explosion. This third explosion can together with the plane rotation explain why the TAWs38 event (landed) was initiated [7]. In agreement with the location of the damaged vegetation patterns the loss of the wing tip took place 100m to 120 m earlier than the birch tree. The distance between the patterns corresponds to the flying distance between the two events (loss of wing lift) as recorded by the Polish QAR black box. The final calculated velocity ($V_z=23$ m/s) towards the ground at the "FMS" point agrees with the recorded value of $V_z=22.2$ m/s. The scenario can also explain why wing parts are found earlier than the birch tree. The calculated vertical acceleration (red line of bottom fig) shows same characteristic decline as the recorded signal.

Signs of vegetation damage are observed in three distinct areas located 120 m apart at positions where fuel spillage from the left wing are expected to occur with a wind direction of about 120° (see Fig. 7). The two first locations are in good agreement with the hypothesis of two wing explosions, the first cutting the wing tip and the second 120m further downstream removing the central part of the wing. The third zone much larger and intense than the two first zones described above and starting another 100m closer to the crash site around the position of the TAWS 38 event as measured by the planes GPS units correlate with the sudden and momentaneous release of a significant amount of fuel. This pointing towards a third explosion at this point. This third explosion most likely explaining the triggering of the "landed" sensor system of the TU-154M due to the mechanical disturbance of the explosion together at a time, where the sensor system is sensitive to such as a result of the plane rotation of 90° or more.

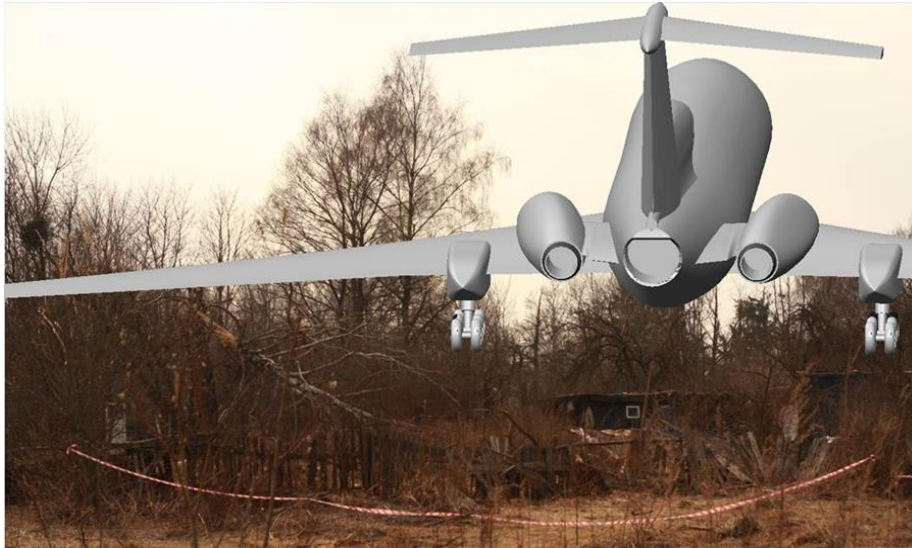
The TU-154M has three Soloviev D-30KU-154 engines with a total thrust power of 309 kN or more than 30 tons of pressure [10]. The engines are located very close to each other at the tail of the plane. By the official data [6] the TU-154M had an inclination of 15° to 20° at the time it was claimed to hit the birch tree in 5 m height above the ground cutting off the left wing tip with the engines at full power in an effort to take off. By the American black box (TAWS) logging of the planes three GPS devices, the planes ground velocity was about 75 m/s at the time of the wing loss [11, 12]. Assuming the exit velocity of the turbine engines to be about 95 % the speed of sound or about 325 m/s and the exit thrust cone angle to be about 20°, the resulting thrust power as felt by ground obstacles will be more than 20 tons. A piece of the old Russian wood fence nearby the birch tree claimed to cut the wing would be in the direct shooting line of the three TU-154M engines as shown in Fig. 8.

Fig. 8. According to the official explanation the plane flew at this height with an inclination of 15° to 20° when the left wing hit the birch tree (the now broken one in the left part of this picture) in 5m height above the ground. Note the fence and shacks will by this story be in the direct line of fire of the planes thrust power.

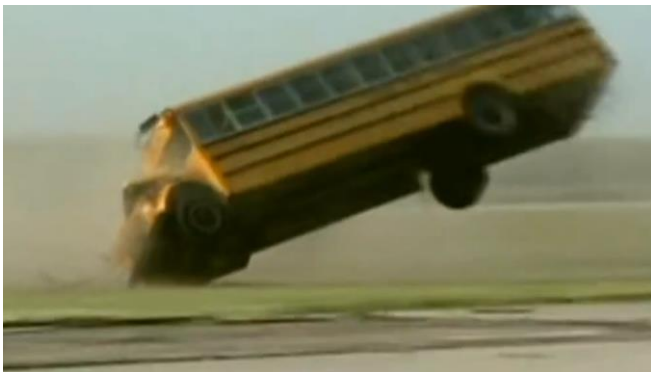
Fig. 9. This bus was pulled 40m behind one 747 engine blowing with the thrust power of the TU-154M. The 11 ton bus was immediately airborne and thrown another 30m - 40m downstream flipping around. See the YouTube video: https://www.youtube.com/watch?v=mj_bB6cUWCs

Assuming a thrust impact zone length of say 40 m, which is a low estimate, the exposure time can be found as $\Delta T = 40 \text{ m} / 75 \text{ m/s} = 0.53 \text{ s}$. Assuming the wood has a density of 800 kg/m^3 , which seems as a high value for the presumably old wood, it is relative easy to show, that the thrust power hitting such fence would accelerate the wood above 17m/s within even the first 0.1s of impact. With otherwords the fence would be torn apart and scattered over a large area just as the small shacks and the roof of the shacks on the stated path of the plane flying past the claimed birch tree. The power of turbine engines is illustrated in [13], where first a classic American 11 ton school bus is towed 40 m behind the engine of a 747 plane. One 747 engine has approximately the same thrust power as all three TU-154M engines. The bus immediately becomes airborne (see Fig. 9) and is tossed 30-40 m downstream.

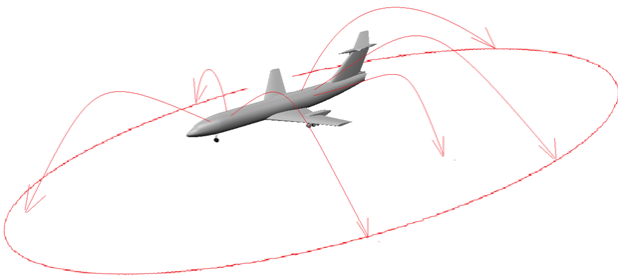
Fig. 11. Fuselage explosions occurring when the plane is in a normal flying position will tend to send parts upwards and outwards due to the main structure of the plane (passenger floor) acting as a shield and directing the pressure wave in this direction.

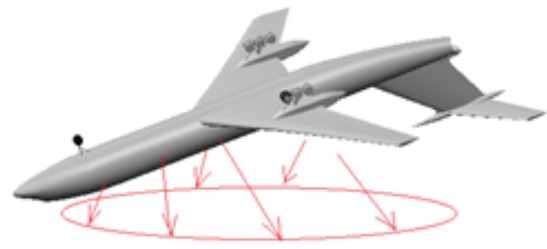
Fig. 12. Fuselage explosions occurring when the plane is in a upside down position will tend to send parts downwards into the ground due to the main structure of the plane (passenger floor) acting as a shield and directing the pressure wave in this direction.

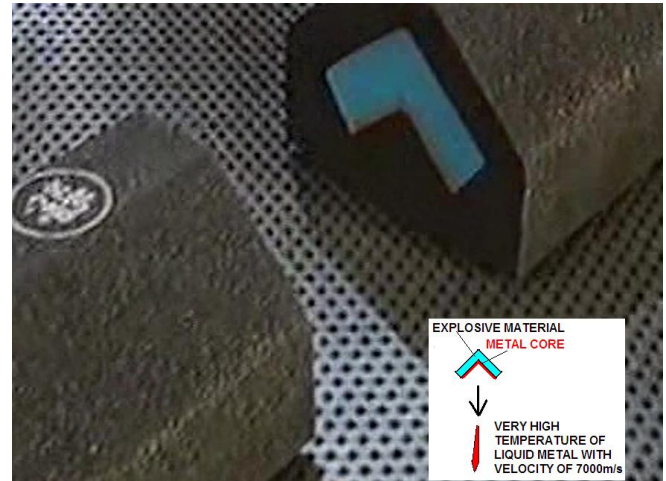
Fig. 14. The directional type explosives will send a liquid metal off with 7000 m/s cutting through almost anything. They can be formed in almost any shape and are found in a large variety of sizes. The metal core is typically copper but can also be aluminum. Traces of the metal will be found on the edges of the cut (exploded) parts.

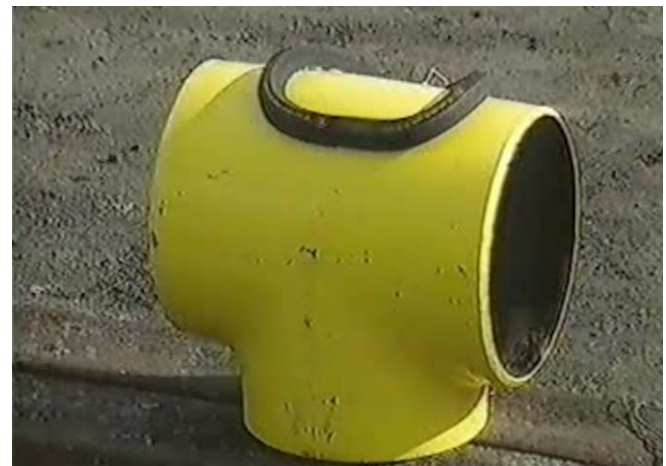
Fig. 15. The explosive can be formed in almost any shape. Here prepared to cut through a steel pipe [15].

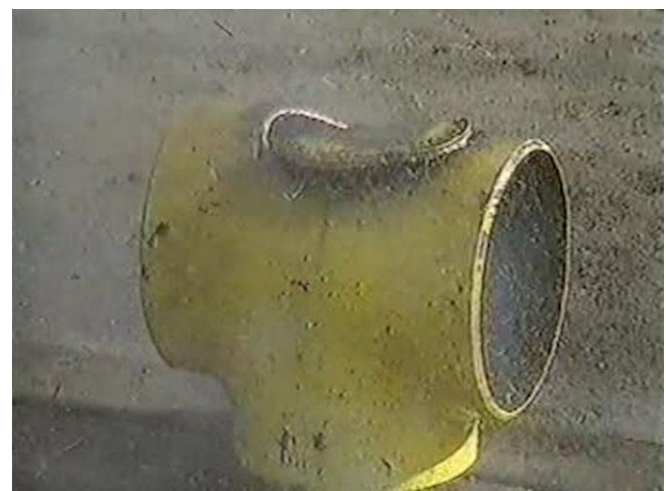
Fig. 16. The circular hole is cut with a sharp edge without throwing the parts around. Traces of the metal core of the directional explosive will deposit on the edges of the cut surfaces, in this case copper. Directional explosives can be found, where the metal core is aluminum matching the material of the wing better. The remainings of the plane will therefore contain valuable investigative information.

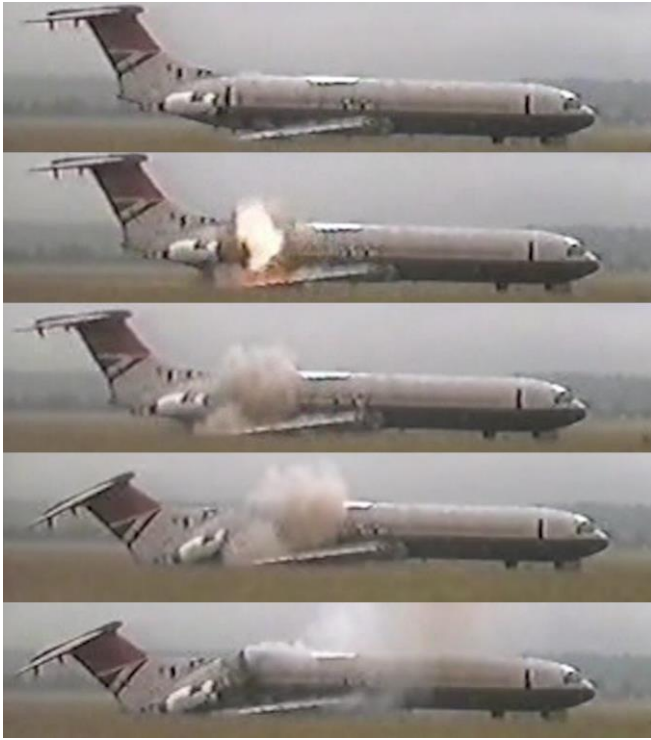
Fig. 17. An experiment performed in 1991 by the British Defense Research Agency [15].

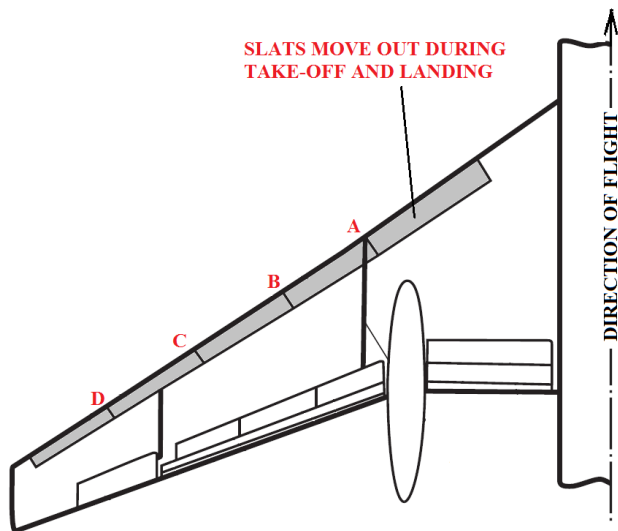
Fig. 18 shows the location of these points, and consideration is required to determine which of the four points to choose. The points noted as "A" and "B" are not good choices, as the wing is thick and wide here. The point "D" is not an option either, as the resulting lost wing area would be very minimal and the resulting angle of cut way out of line with the direction of flight. This leaves point "C" as the only point where to fake the cutting obstacle (tree/mast) entered the wing at the leading edge.

Fig. 18. The slats move out during take-off and landing, and cutting these moving parts with explosives would be complicated and involve a big risk of detection. At the points A to D a natural division already exists from manufacture [16].

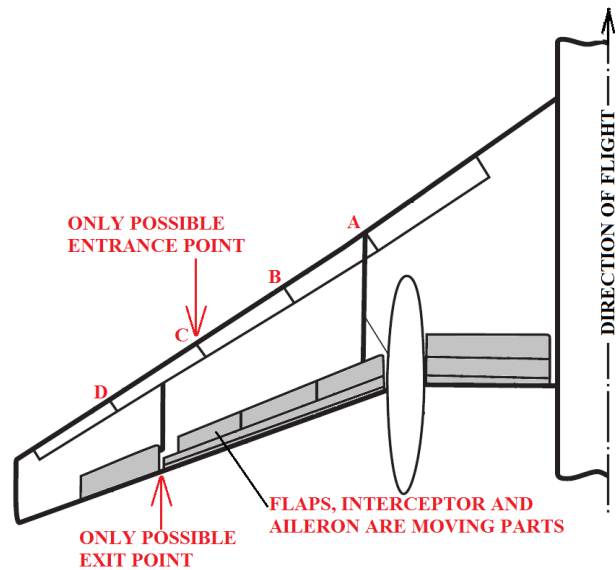
Fig. 19. Point C is the only option available for the fake entrance. On the trailing edge the aileron, flaps and interceptors are moving parts, and cutting through these moving parts with explosives would be complicated and involve a big risk of detection. The only possible exit point is between the outer interceptor and aileron.

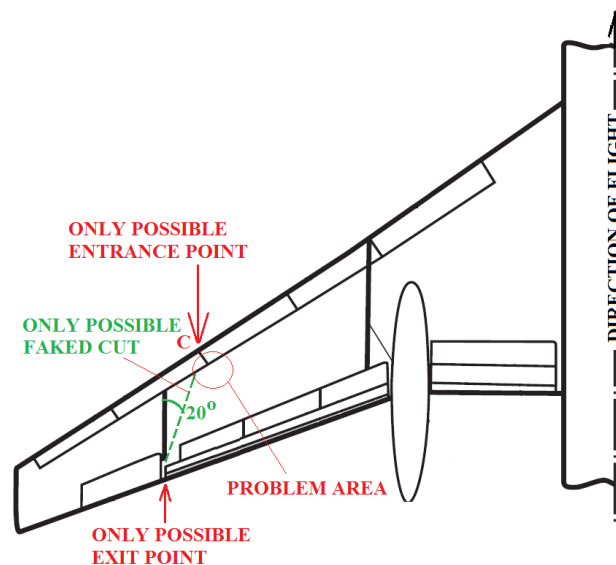
Now the question is where the birch tree or mast should exit the wing on the trailing edge of the wing. In order to fake this as perfect as possible, the natural exit point would be just behind the entrance point resulting in a cutting line in the direction of flight. The problem with this approach is that the outer interceptor and outer flaps located at this point are **moving parts, and any explosives mounted to cut these** would easily be spotted. The only possible exit point without a "moving part problem" for such fake cut would be, at the section between the outer interceptor and the aileron. See Fig. 19. The result is that there only exists one possibility for the fake cut as shown in Fig. 20. Note that this faked line of cut makes an unexplainable angle of nearly

Fig. 20. The green dashed line shows the only possible choice of the faked cut. This line makes an angle of about 20° with the direction of flight. Note also there is expected to be an unavoidable problem area marked with the red circle, where the edge of the slat does not fit with the line of cut.

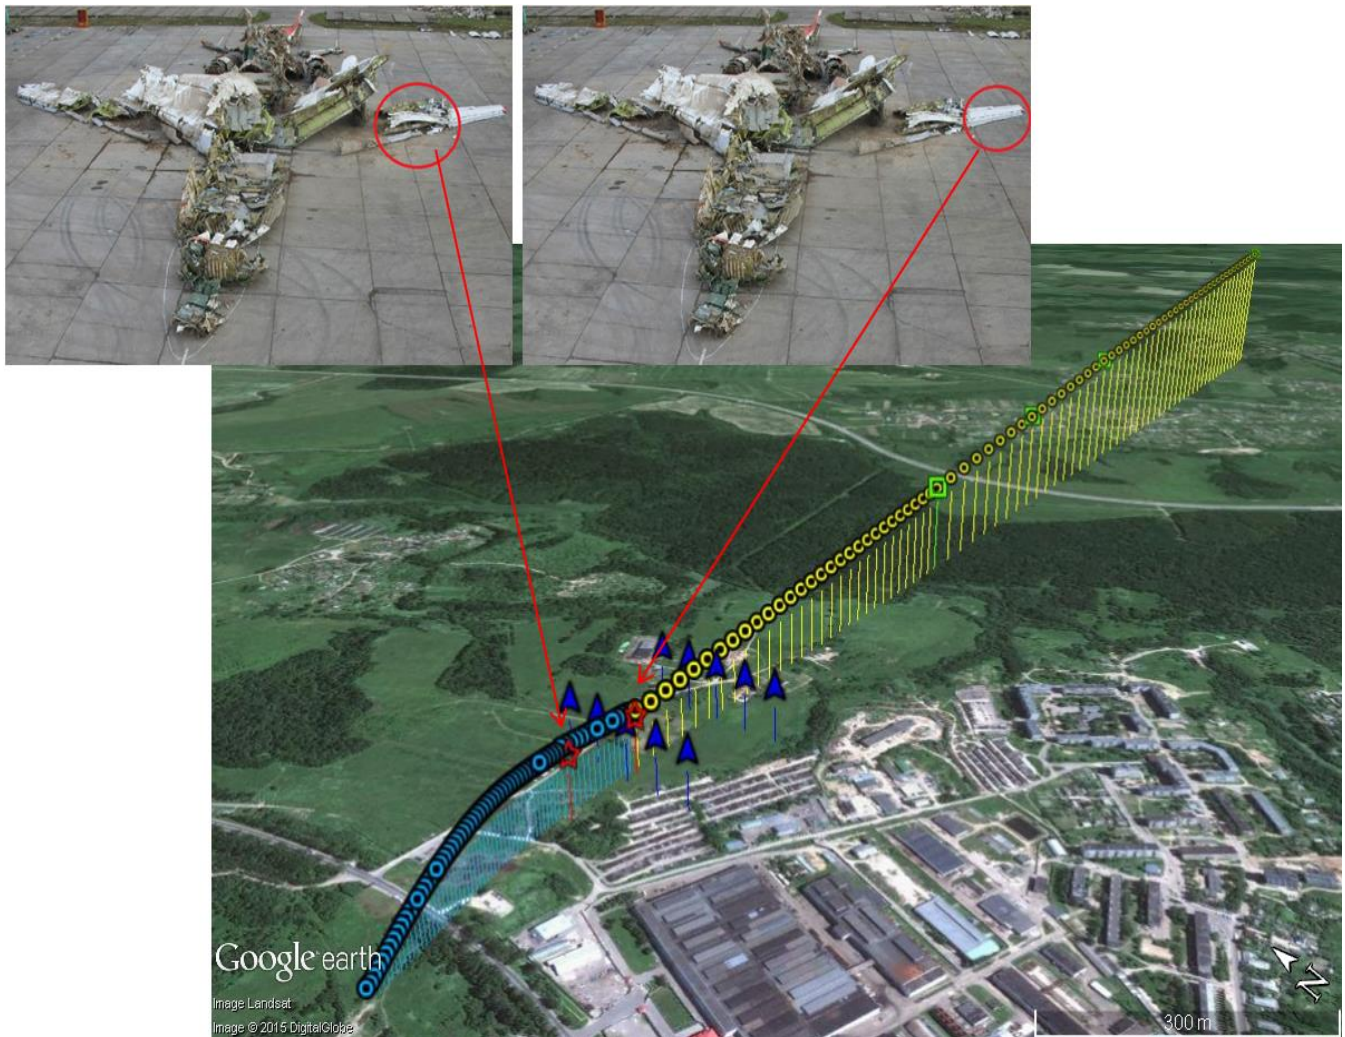
Fig. 23. The plane can be brought to crash at the desired location for the entire range of heights. All the planner has to do is rely on the competent pilots bringing the plane within the upper and lower glide paths, of course aided by the tower tracking the planes height by radar and ground personnel, and keeping the plane "on course" and "on path". Here is shown where the wing tip was lost and where the central wing part was damaged. The green squares are GPS logged positions and heights and the blue triangles show the middle marker entry and exit [7].

During the approach the pilots will to a **large extent control the main parameters of** importance such as plane speed and height. Here the goal from the engineering perspective is to have the plane crash at the desired position in all expected initial boundary conditions. Aero dynamical calculations show that all that is required to obtain this, is to rely on the pilots being competent, i.e. the plane is within the lower and upper glide paths with speeds within the allowed range [7] and maybe a slight adjustment of the timing of the loss of wing area according to the height. This timing can require ground personnel located near the middle marker as previously mentioned. In addition the planes height can be monitored by the airfield radar, and necessary corrections can be given to the pilots if this is required making sure the plane is "on path" and "on course" (see Fig. 23). The pilots should be encouraged to bring the plane

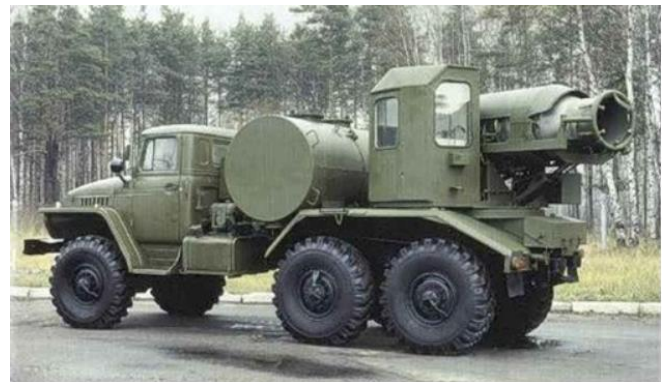
Fig. 25. An earlier serial produced version of the Russian truck based TMC65 fog generator.

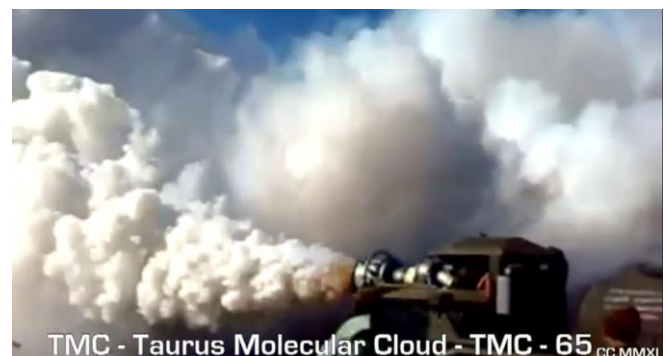
Fig. 26. The newer Russian TMC fog generator in action. For video see [18].
