ANALYSIS OF COMPONENTS OF ELECTRIC SYSTEM OF THE TU-154M PLF 101 AFTER CRASH

Jacek F. Gieras¹⁾, Marek Dąbrowski²⁾

Abstract

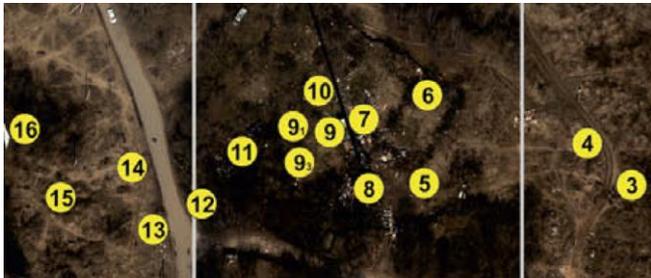
9	Fragment of the left aileron, left flap fairing. Fragment of left slat.	845	-42
9.1	Left outer flap tip.	838	-36
9.2	Left outer flap tip fairing, TM-4, D-10ARU №00900002.	838	-37
9.3	Left flap track, slat fragment, flap housing.	837	-42
10	Fragment of left wing skin panel.	839	-30

Fig. 7. Fragments of Tu-154M PLF 101 on the wreckage field before Gubenko Street according to Interstate Aviation Committee (MAK) [8]. 3 - site of impact №2 on a tree, h=4.1m, 4 - site of impact №3 on a group of trees, 5 - site of impact №4 on a group of trees, 6 - site of impact №5 on a group of trees, 7 - site of impact №6 on a tree, h=4.8m, 8 - fragments of the left wing in the tree trunk, h=5m, 9 - fragment of the left aileron, left flap fairing, fragment of left slat, 9.1 - left outer flap tip, 9.2 - left outer flap tip fairing, ТЭМ-4, Д-10 АРУ №00900002, 9.3 - left flap track, slat fragment, flap housing, 10 - fragment of left wing skin panel, 11 - spoiler track drive fragment №15483514131 of the left outer wing, 12 - fragment of the outer slat tip of the left outer wing, 13 - fragments of left wing skin panels, flap drive gear box fragment, 14 - flap drive fragment, 15 - collision with power lines and wire tear off, 16 - fragment of left outer wing with a fragment of slat, left aileron.

4. It is unknown if original places of fall have been accurately recorded and described by investigators. Both official Russian report [8] and Polish report [9, 6] show coordinates of fragments at the crash site, e.g., Fig. 7, but credibility of these reports is questionable.

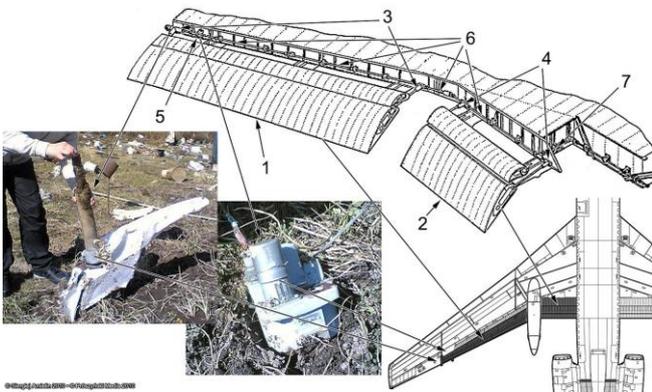
The principle of the flap control of the Tu-154M aircraft is shown in Fig. 12 Flap actuators are used to move the flaps transforming screw rotation into forward movement of flaps. The angle of deflection of flaps is from 0° to 45°. A hydro-electro-mechanical system has been designed for pulling-out and retraction of flaps. The mechanism SPZ-1A for moving the flaps consists of a transmission and screw actuators. The transmission of flaps transfers the torque from the steering gear to the screw actuators and provides synchronous sweep-up and pull-out of flaps on right and left wings. Transmission is located on the rear wall of the third spar including the detachable part of the wing. Transmission consists of shafts, supports, airtight tips (terminals) and reducers. Shafts are made of mutually connected duralumin transmission tubes, reducers, slotted tips of screw actuators and cardan shafts. Cardan shafts are used to connect the transmission shafts if their axles intersect at an angle of up to 8°. Cardans eliminate bending and jamming of transmissions upon deformation of the wing and serve to compensate for this mutual displacement of its mechanisms.

Fig. 12. Parts of flap control system found on crash site and principle of flap control of the Tu-154M aircraft. 1 – outer flap, 2 - inner flap, 3 - screw actuator of outer flap control, 4 - screw actuator of inner flap control, 5 - electromagnetic brake TEM-4 of mechanism of flaps, 6 - transmission shaft, 7 - hydraulic motor. Source: S. Amielin [110].
